Forest Service Groundwater Dependent Ecosystems Protocol: Assessing the Function and Condition of Springs and Isolated Wetlands

Level I - Qualitatively locate and
characterize GDEs

Level II - Quantitatively describe
major ecosystem attributes

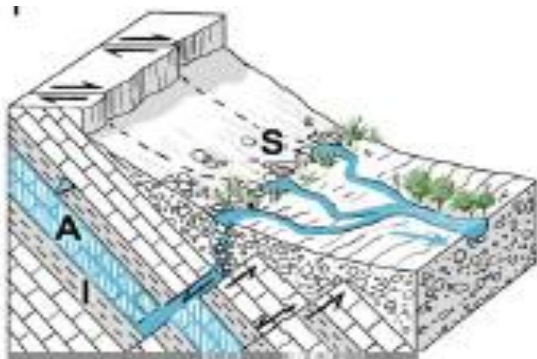
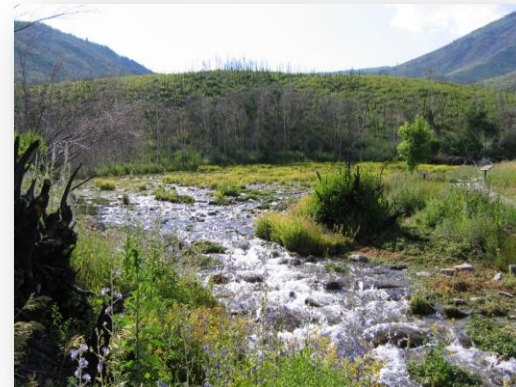
Springer and Stevens, 2009

A - Aquifer I - Impermeable Stratum S - Spring Source

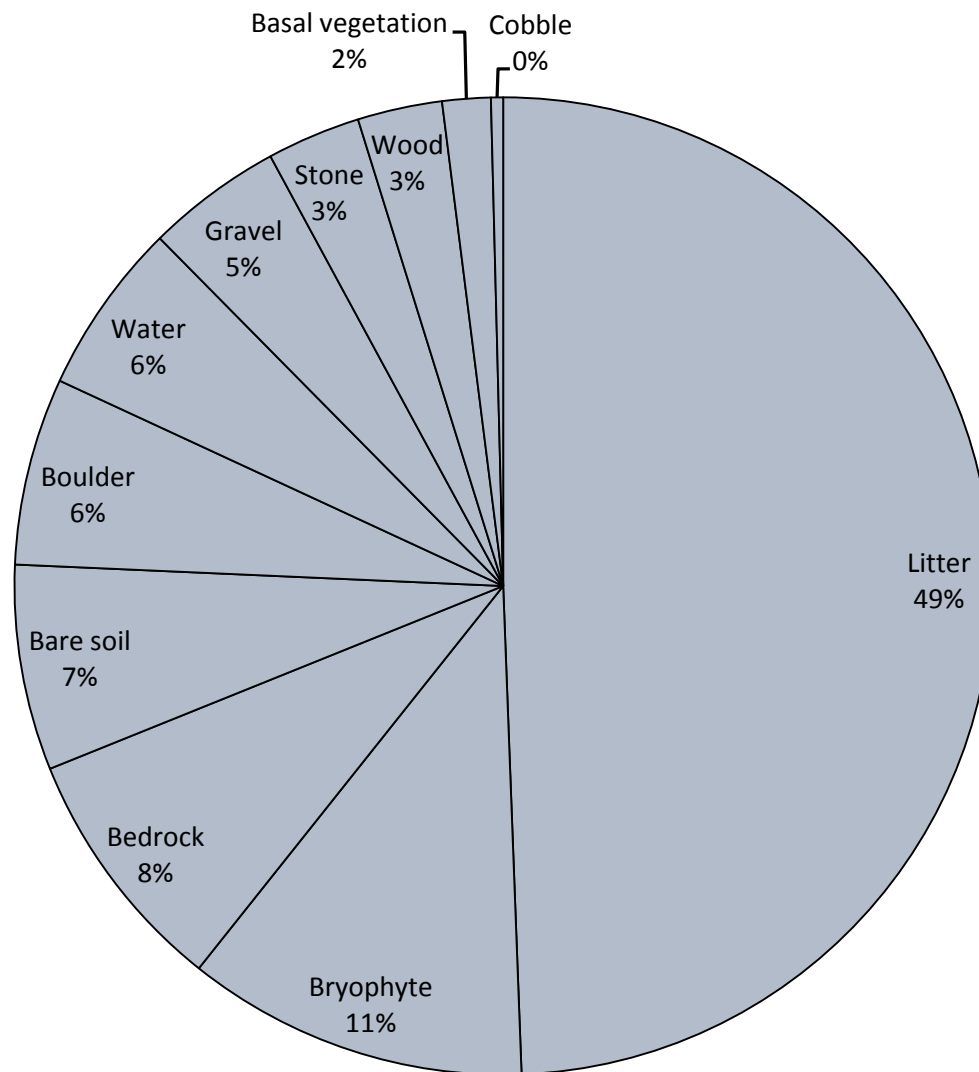
Ground Cover - Spring Mountains NRA

N=47

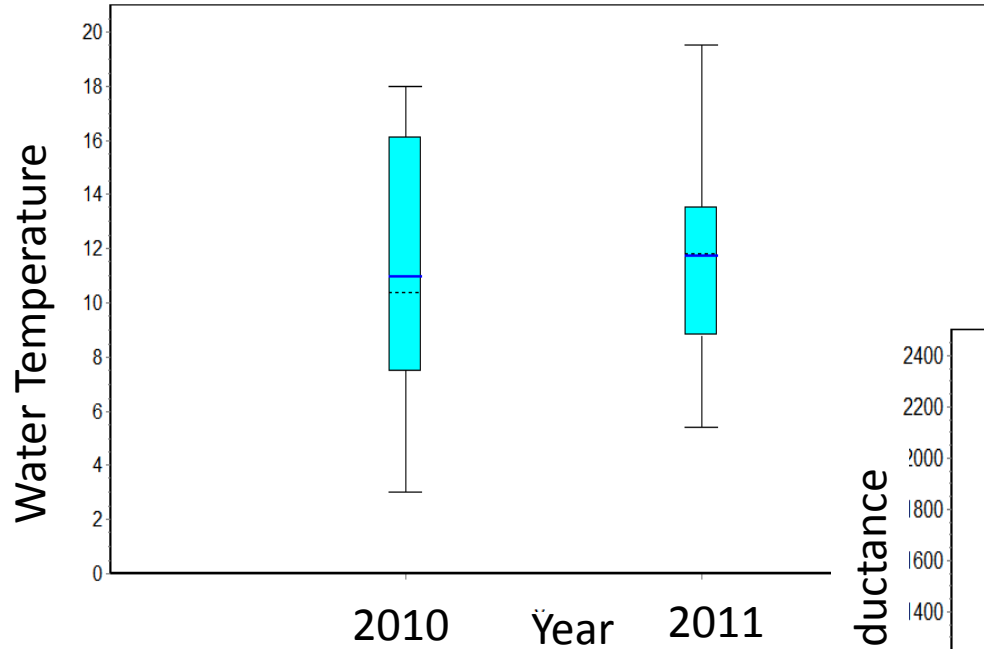
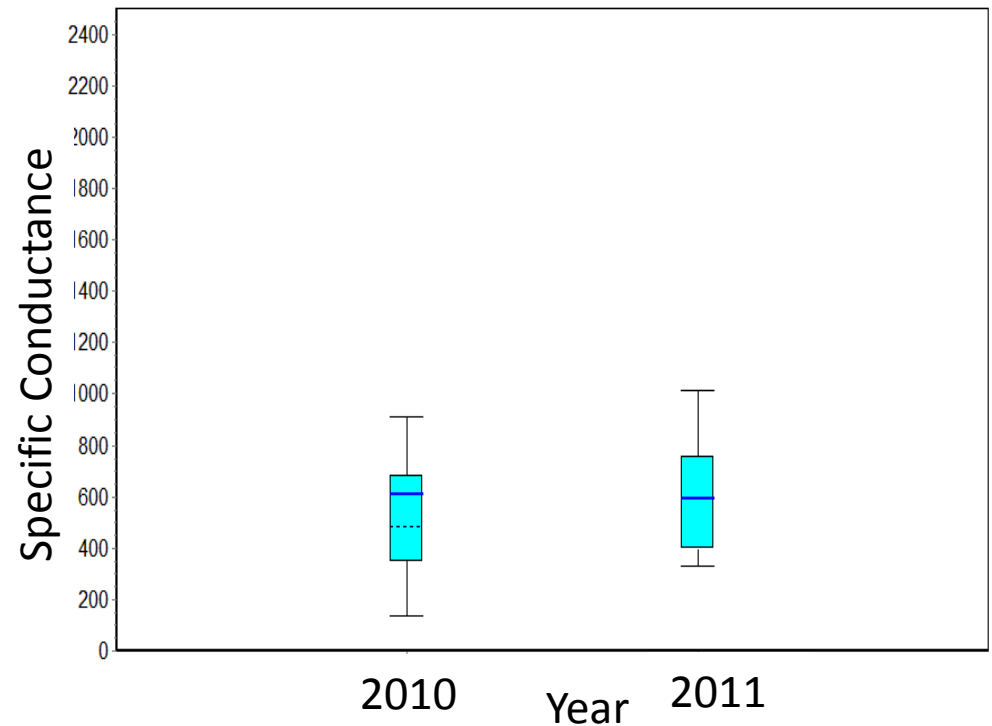
Water Quality - Spring Mountains NRA

N=47

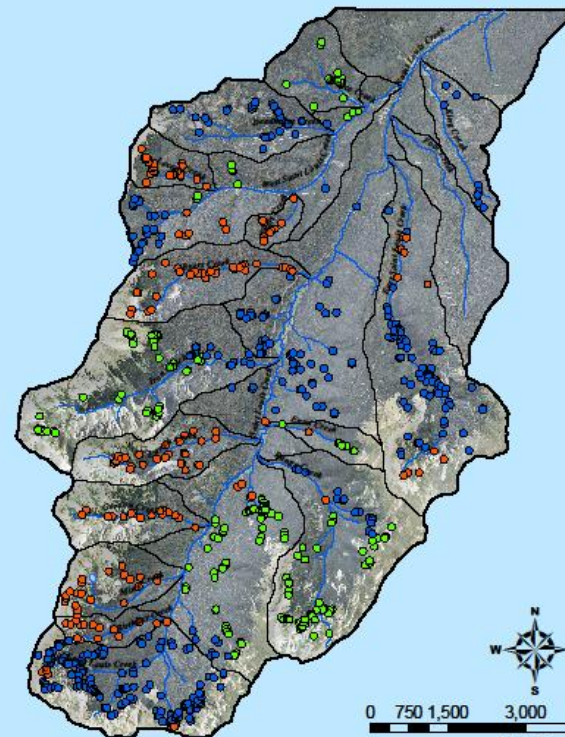
Fraser Experimental Forest - Spring Location

This map depicts the location of springs identified at the Fraser Experimental Forest during an inventory of springs and wetlands. The inventory was conducted during the snow-free months (summer) for years 2009 - 2011. Inventory is expected to be completed following summer 2012.
